Tenneco Minerals

Reference: Response to Your Letter of April 5, 1990

CHRONOLOGY OF EVENTS

RESPONSES TO APRIL 5, 1990 LETTER

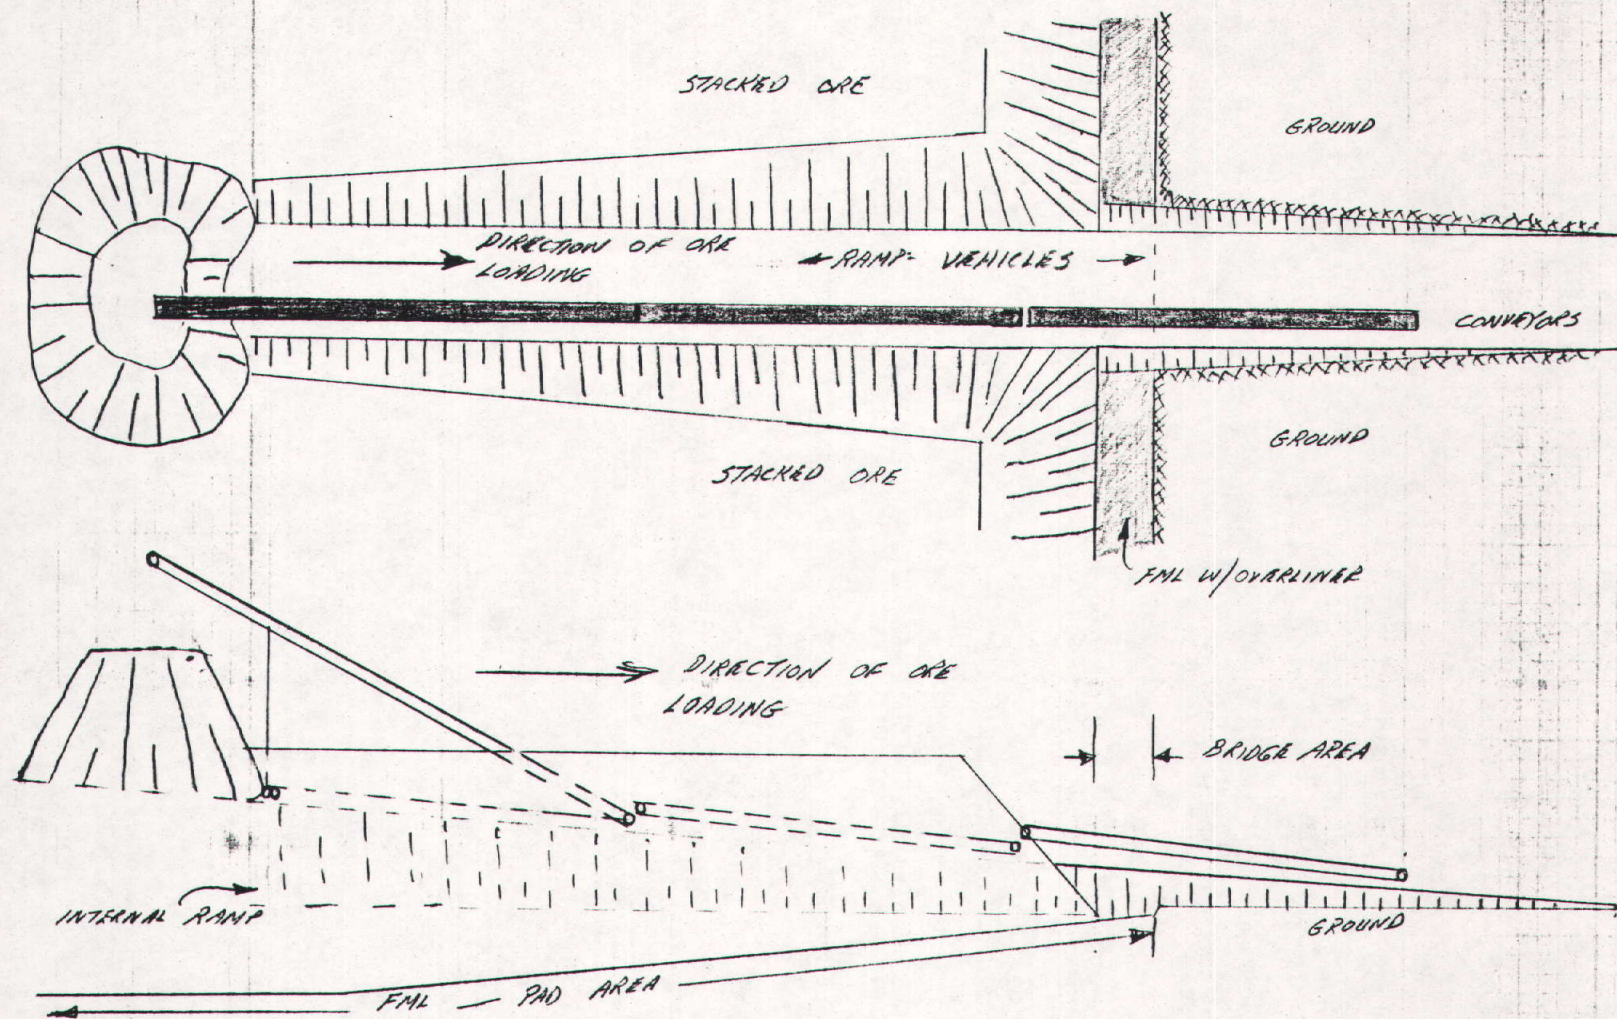
FIGURE 1. LEARN PAD 1 - CELL 7
FINAL LOADING

- 1) February 16, 1990: Mining contractor concludes loading of ore onto leach pad #1, cell 7. Final ore is stacked onto pad access ramp (Figure 1).
- 2) February 18, 1990: TMC personnel conclude piping installation on leach pad #1, cell 7. Entire cell is under irrigation (Figure 2).

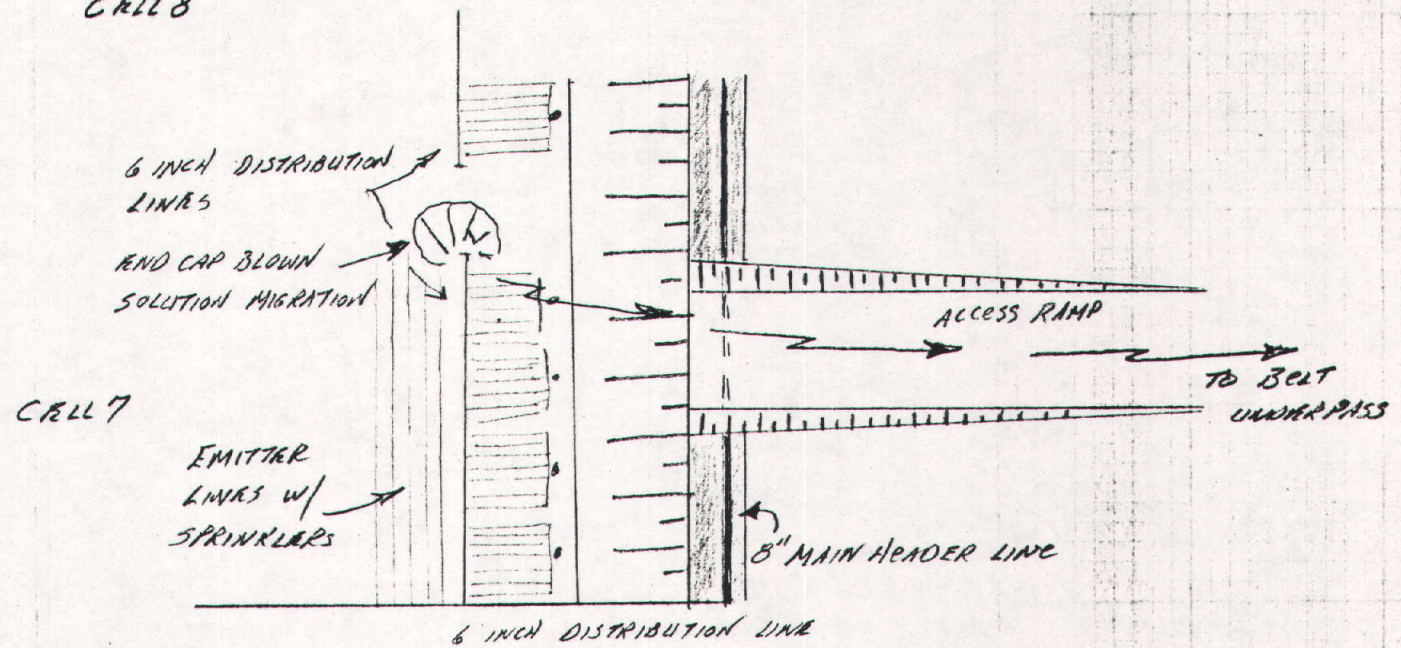
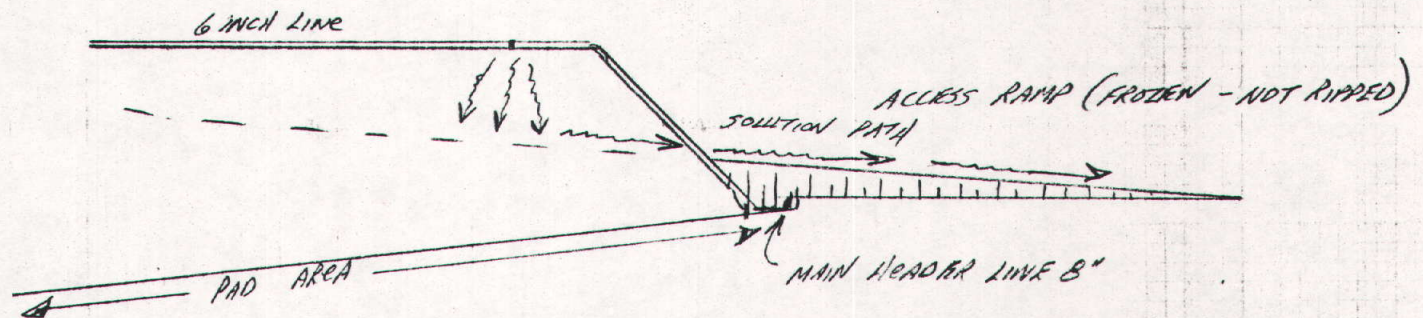
FIGURE 3. LEACH PAD 1 - CELL 7
1ST SOLUTION BREACH PATH

- 3) February 21, 1990: (Figure 3) 4:30 p.m. solution breach occurs on leach pad #1, cell 7. 8000 gallons of barren solution pours through a six-inch pipe end cap which is blown off due to a faulty pipe clamp. The solutions penetrate the heap and contact the conveyor belt access ramp. The ramp is not ripped and bermed, consequently, the solutions travel horizontally and effuse the heap along the south heap face. Solutions then travel across the exposed frozen access ramp to a belt underpass. The system is shutdown by 4:39 p.m. Neutralization is put into effect with 8 lbs of calcium hypochlorite. The contained solutions are scooped up and placed onto the leach pad. The "mudded" areas are mixed with mine waste and removed to the leach pad. The ramp area is ripped and bermed to prevent future occurrences (Figure 4). Leaching resumes upon pipe repair.

These two events would not have happened had we and our mining contractor followed standard operating procedure which is to cross-rip ALL access ramps onto the leach pads. Unfortunately, two tasks were missed upon completing cell 7. First, over the pad area proper, we failed to cross-rip the conveyor access ramp. Thus, due to the densification of the material while running equipment over the ramp, we created a solution pathway which would encourage horizontal solution movement. This area subsequently was covered with crushed ore and leach piping was placed on top (see Figure 2). Second, in the berm "bridge" area (ground to pad interface), we failed to cross-rip and berm the access ramp. Upon freezing and wet weather, this further "sealed" the ramp and created a pathway beyond containment.

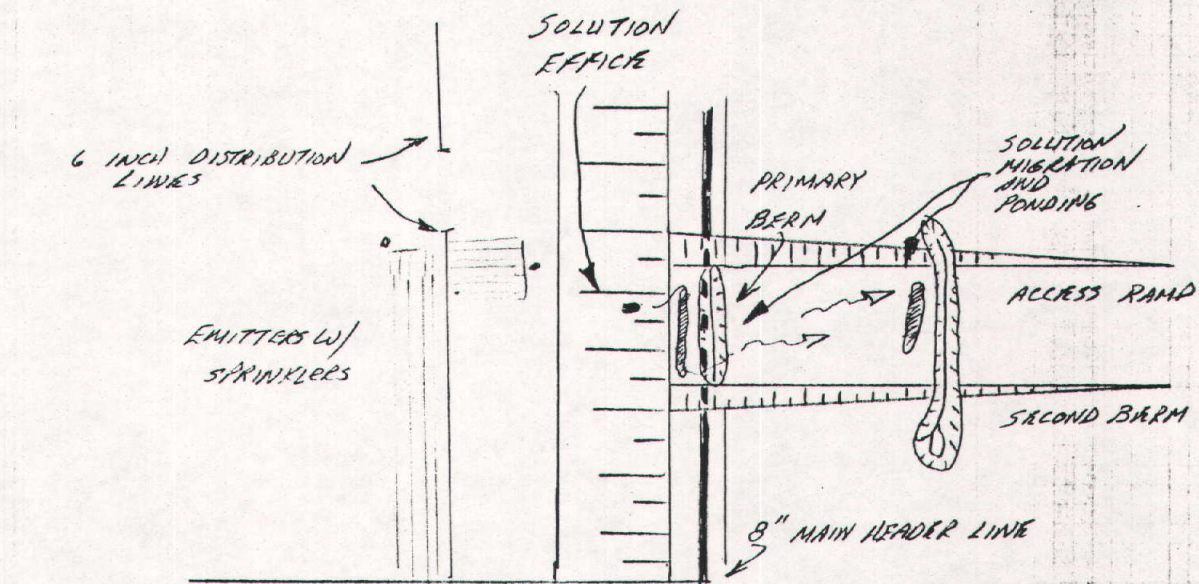
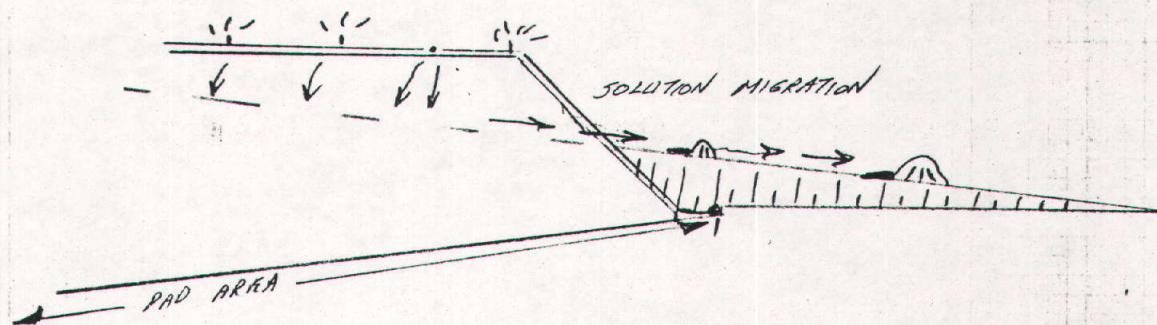
FIGURE 5. LEACH PAD 1 - CELL 7
SECOND BREACH SOLUTION FLOW PATH

- 7) March 9, 1990: (Figure 5) 4:35 p.m. second solution breach is observed on leach pad #1, cell 7. Approximately 300 gallons of cyanide solution is observed to have worked beyond the ripped and bermed portion of the old conveyor access ramp. The solutions are trapped from further movement by a second clay berm. The solutions are analyzed and determined to be process solution. Neutralization is immediately placed into effect. Approximately .8lbs of calcium hypochlorite is added to the solutions. Cell 7 end pipe is removed from leaching (Figure 6). Notification is made to the Utah Bureau of Water Pollution Control, Utah Division of Oil, Gas, and Mining and Southwest District Health Department (BLM cannot be reached).

Our first response should have corrected the problem of containment. However, we now recognize that solutions were still capable of reaching the ripped and bermed segment rather than flowing vertically (due to our inability to affect the ore-covered ramp). Additive to this was the events themselves. The end cap rupture created a sizeable amount of solution in a relatively small area. This ultimately led to heap channeling when the solutions reached the covered access ramp. Solutions then "surfaced" on the heap side exposure. This channeling happened again when cell 7 was started up ultimately causing the second breach.

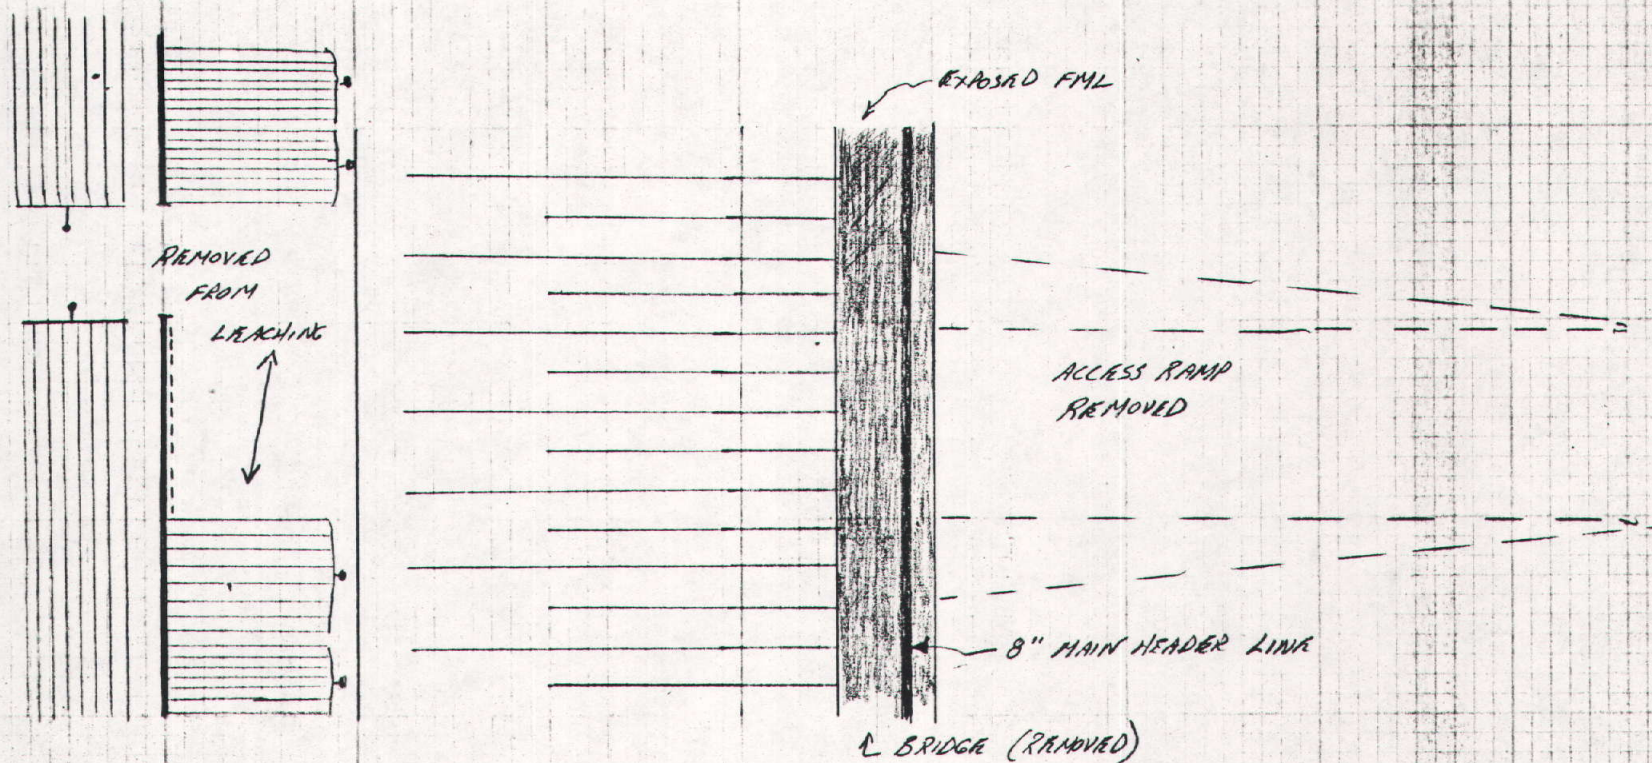
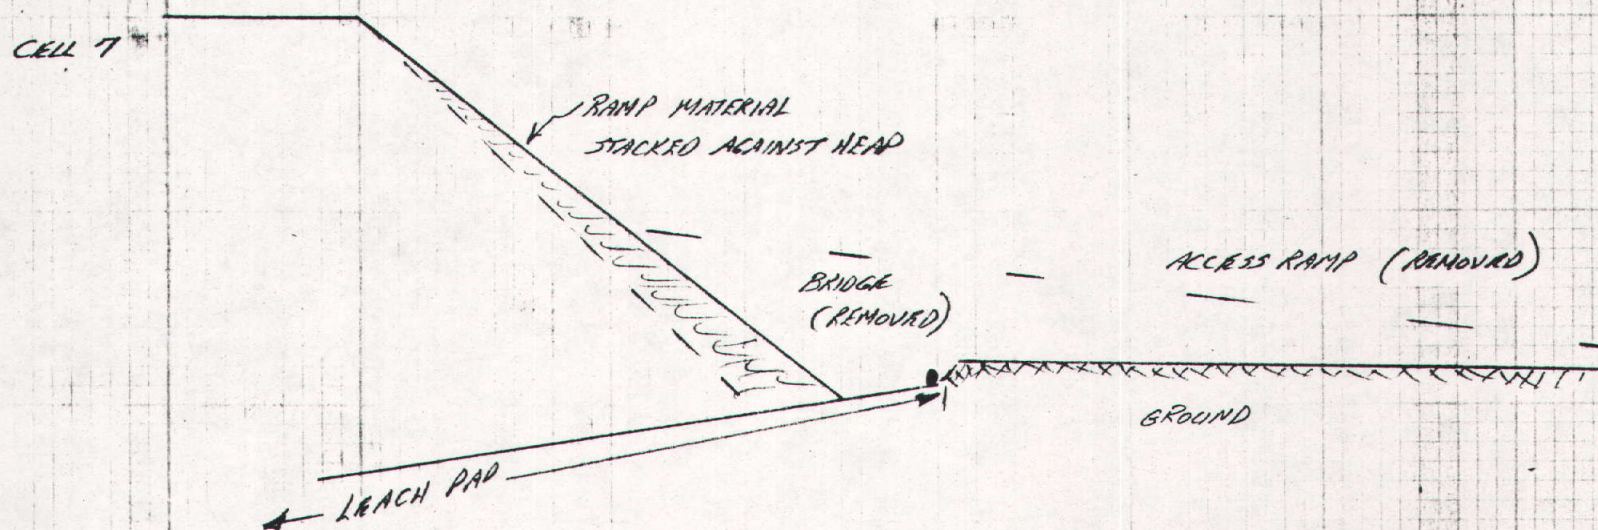
FIGURE 6. LEACH PAD 1 - CELL 7
REMEDIAL ACTIONS BRANCH 2

- 8) March 10, 1990: (Figure 6) site cleanup begins. Access ramp is entirely removed from the leach pad contact. The FML is exposed to contain solutions and not allow "bridging". Preliminary soil samples are taken during clean-up. Site laboratory confirms 12.5 ppm cyanide. An additional 1/4 lb of calcium hypochlorite is added and an additional 1 foot of surface material is removed. Additional soil tests indicate no cyanide detected.

Our second response completely eliminated the access ramp, hence no breach beyond containment can occur. Secondly, we completely removed the "channeled" area from surface leach. We have not seen any evidence of solutions effusing the side of the heap since. In the future we will: (Figure 7).
